# Damage Mechanisms in Bithermal and Thermomechanical Fatigue of Haynes 188

Prepared for the  
Symposium on Thermo-Mechanical Fatigue Behavior of Materials  
sponsored by the American Society for Testing and Materials  
San Diego, California, October 16, 1991

(NASA-TM-105381) DAMAGE MECHANISMS IN  
BITHERMAL AND THERMOMECHANICAL FATIGUE OF  
HAYNES 188 (NASA) 19 p CSCL 20K

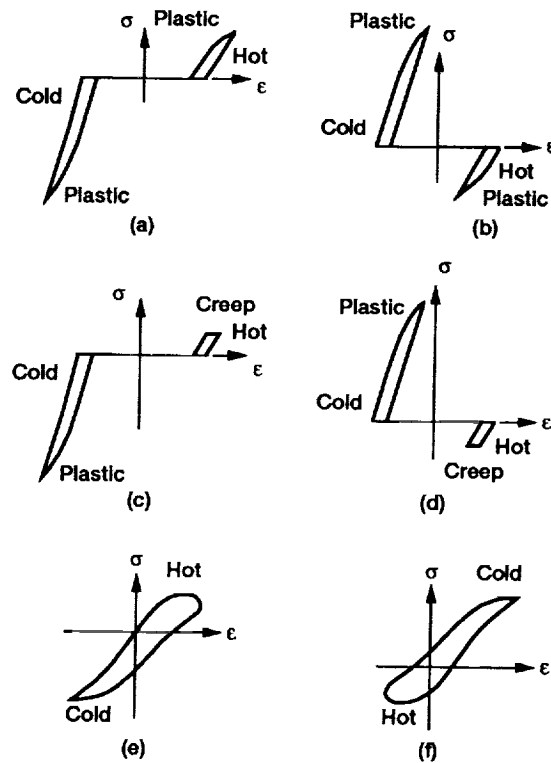
- (a) Bithermal high rate in-phase test (HRIP).
- (b) Bithermal high rate out-of-phase test (HROP).
- (c) Bithermal tensile creep in-phase test (TCIP).
- (d) Bithermal compressive creep out-of-phase test (CCOP).
- (e) Thermomechanical in-phase test (TMIP).
- (f) Thermomechanical out-of-phase test (TMOP).

Figure 2.—Schematic hysteresis loops of bithermal and thermomechanical fatigue tests.

Typical BF tests (refs. 1, 4, and 5) consist of two load-controlled, strain-limited, isothermal segments of loading, one each for tensile and compressive halves of the hysteresis loop (fig. 2). Temperature of the specimen is changed between the higher and lower values under zero load in a BF test to facilitate free thermal expansion of the specimen. During an in-phase BF test, the tensile half of the hysteresis loop occurs at the higher isothermal temperature whereas during an out-of-phase BF test it occurs at the lower isothermal temperature. The mechanical and thermal strains are applied to the specimen sequentially in load controlled BF tests as opposed to the conventional strain controlled TMF tests where the mechanical and thermal strains are applied simultaneously to the specimen (fig. 2).

In a BF test at the higher temperature, time-independent inelastic strain (high loading rate) or time-dependent inelastic strain (high loading rate followed by a load-hold) or a combination of the two can be imposed on the specimen (fig. 2). Thus, by properly choosing the temperature limits, loading rates and load levels in a BF test, it is possible to separately induce the time-independent and -dependent damage mechanisms under nonisothermal conditions (ref. 1). Conventional TMF tests do not permit such a separation of damage mechanisms because of the relatively long cycle times that are required to accommodate the continuous temperature change in a cycle. The BF tests can capture potential thermal free expansion mismatch effect between the oxide layers and substrate (ref. 1). However, there is a possibility of thermal recovery of the material during the temperature changes under zero load in BF tests which is not necessarily present in TMF tests. If simultaneously applied thermal and mechanical strains precipitate some synergistic damage mechanisms in a material then BF would not be able to capture such damage mechanisms (ref. 11). In summary, BF tests can capture some of the damage mechanisms that prevail in conventional TMF tests. For additional details on bithermal and thermomechanical fatigue tests the reader is referred to references 1, 4, and 5.

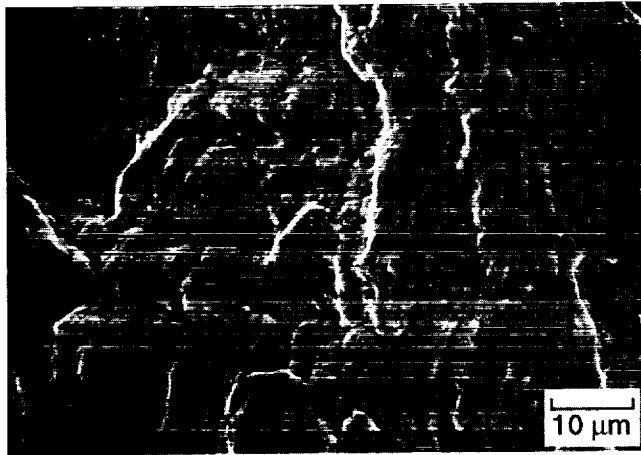
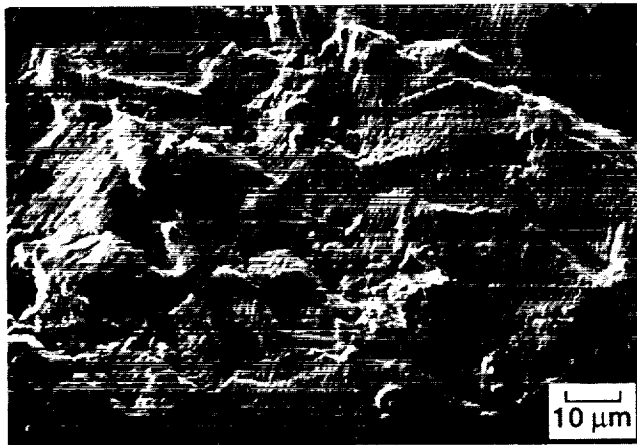
(a) HRIP test.

(b) HROP test.

Figure 3.—Transgranular fracture and striations in bithermal fatigue tests.

In the bithermal HRIP and HROP tests (table I), as in the case of an isothermal high rate strain cycling fatigue test, transgranular cracking and fatigue striations were observed (fig. 3). A larger number of striations was visible in the HROP test than in the HRIP test. This is possibly due to the higher cyclic life of the HROP test (table I). In both cases the observed striations exhibited nonuniform spacing and direction which indicated an irregular crack front movement compared to classic fatigue striations. These striations are referred to as "distorted" striations. The "distorted" striations indicate the presence of secondary grain boundary activity possibly caused by crystallographic slip in these types of bithermal tests.

The bithermal HRIP and HROP tests, due to their high rate of loading, excluded time-dependent creep deformation. The fracture surfaces exhibited transgranular cracking and slightly "distorted" striations (fig. 3). Among the bithermal tests that contained creep the TCIP test exhibited intergranular cracking and no striations (fig. 4) whereas the CCOP test exhibited transgranular fracture and highly "distorted" striations (fig. 5). These results indicate that formation of striations occurred both at 316 and 760 °C in BF tests whenever tensile time-independent plastic deformation was applied. The highly "distorted" striations in the bithermal out-of-phase CCOP test indicate a higher level of interaction between the striations and the grain boundaries they intersect than encountered in the bithermal out-of-phase HROP test. Since the CCOP test involved compressive creep instead of compressive plasticity at 760 °C, it is inferred that this creep deformation contributed to the interaction between the grain

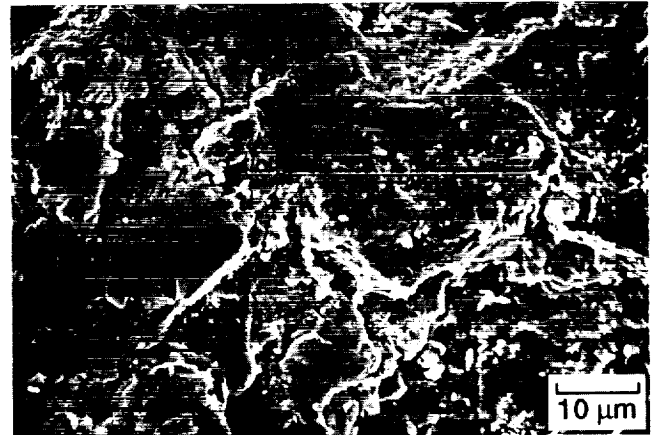
Figure 4.—Intergranular cracking in bithermal TCIP test.

In the bithermal TCIP test, fracture surface topography indicated intergranular cracking and no striations were observed (fig. 4). Multiple regions of intergranular cracking were observed and the area between these regions failed in a ductile, tearing mode. On the contrary, the fracture surface of the bithermal CCOP test exhibited a transgranular mode of failure and heavily "distorted" striations (fig. 5), possibly due to grain boundary sliding in compressive creep and the subsequent tensile plasticity. Similar fractographic features were observed for an austenitic stainless steel under isothermal, tensile creep reversed by compressive plasticity, and compressive creep reversed by tensile plasticity, cyclic loading conditions (refs. 13 and 14).

It is indicated earlier in the paper that most of the fracture surface features of the TCIP and TMIP tests (figs. 4 and 6) as well as the CCOP and TMOP tests (figs. 5 and 7) were similar. Such a resemblance for Haynes 188 indicates the absence of synergistic damage mechanisms in TMF due to simultaneous application of temperature and mechanical loads within the temperature range of 316 to 760 °C. The resemblance between the fracture surfaces of BF and TMF tests is not unexpected because the TMF tests, both in-phase and out-of-phase, embody the same deformation modes as those in the BF tests. For instance in the TMIP test, creep and plasticity are applied in tension with plasticity in compression, which is similar to the combination of deformations in TCIP and HRIP tests. Likewise in a TMOP test, creep and plasticity are applied in compression with plasticity in tension, which is similar to the deformation in a combination of CCOP and HROP tests.

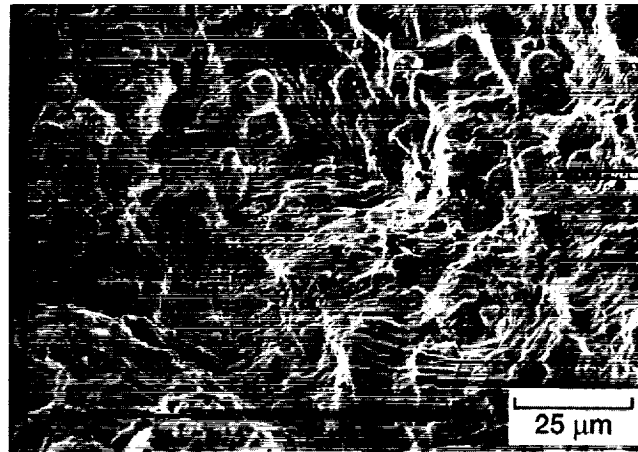
Figure 5.—Transgranular cracking and heavily distorted striations in bithermal CCOP test.

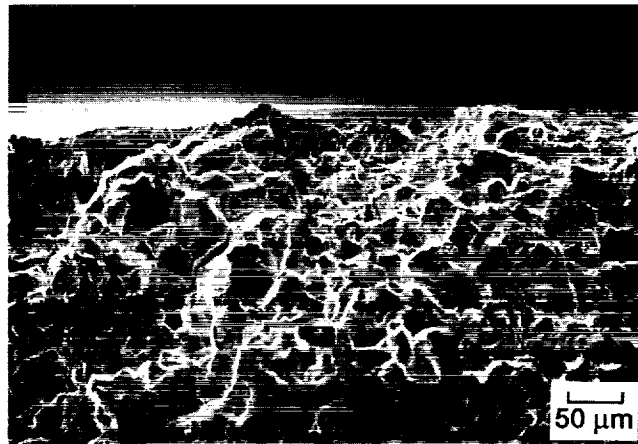
Figure 6.—Intergranular fracture in TMIP test.

Fracture surface topography for the thermomechanical TMIP test was distinctly intergranular with no striations (fig. 6). These fracture surface features are similar to those observed in the bithermal TCIP test (fig. 4). In the case of the TMOP test the fracture surface was transgranular with mildly "distorted" striations (fig. 7). However, occasional regions of intergranular fracture were also observed. The mildly "distorted" striations indicate a lower level of grain boundary activity in the TMOP test as compared to the CCOP test.

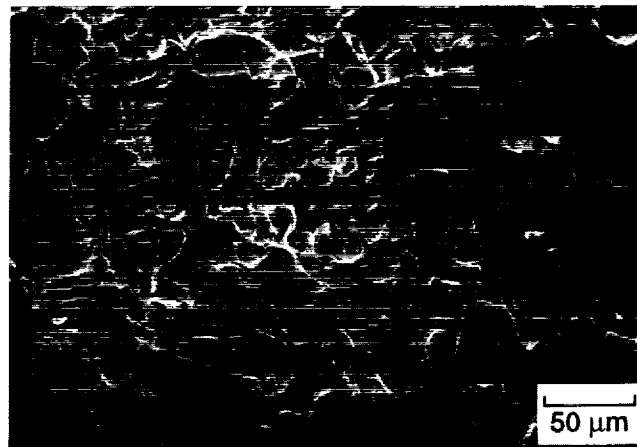
Figure 7.—Transgranular fracture and mildly distorted striations in TMOP test.

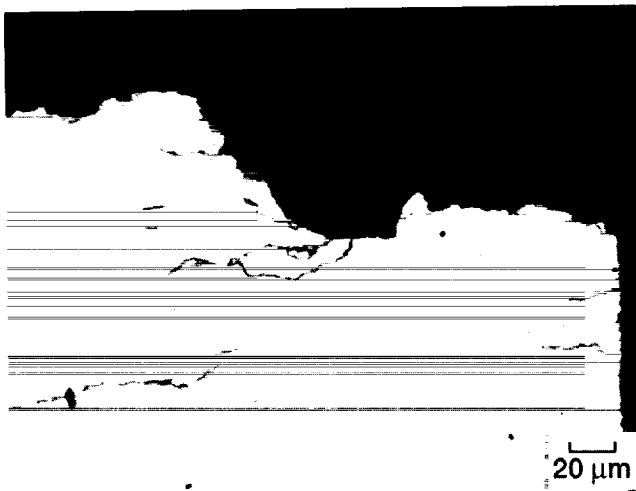
(a) TCIP test.

(b) CCOP test.

Figure 8.—Oxide formation in bithermal tests.

Specimens were longitudinally sectioned and mounted in bakelite to preserve the oxide laden edges during sample preparation. The polished specimens were then photographed before etching (to preserve the oxide layer) with an optical microscope to document the oxidation patterns in each bithermal and thermomechanical test. For the metallographic photographs presented in this paper (figs. 8 to 15), vertical direction of the page corresponds to the mechanical loading direction of the hourglass fatigue specimen. No discernible oxide formed in the bithermal HRIP test on the external surface of the specimen. In the case of the bithermal HROP test very small amounts of oxide were noticed near the opened fracture surface. In the bithermal TCIP test oxide formed along the grain boundaries and secondary cracks (fig. 8(a); grey colored regions are oxides). Extensive formation of oxide was observed on the fracture and external surfaces of the bithermal CCOP test specimen (fig. 8(b)). In this test the specimen was subjected to the lowest creep stress at high temperature for the longest amount of time among the four bithermal tests. In the TMIP test, small amounts of oxide were observed in the intergranular cracks (fig. 9(a)). The oxidation pattern in the TMIP test is similar to that in the TCIP test (fig. 8(a)).

Moderate amounts of oxide were formed on the side of the specimen and along the main crack that caused failure in the TMOP test (fig. 9(b)). The thickness of oxide scale formed in the TMOP test was less than that formed in the CCOP test (fig. 8(b)), which had a longer time to failure.

In both the BF and TMF tests (except in the CCOP test) the thicknesses of the oxide layers are small (figs. 8 and 9). This is a testimony to the oxidation resistance of Haynes 188. However, at temperatures greater than 760 °C oxidation may play an important role in limiting the fatigue life of Haynes 188. Oxides formed mainly along the grain boundaries in the bithermal TCIP and thermomechanical TMIP tests (figs. 8 and 9). No oxidation of grain boundaries was noticed in the CCOP and TMOP tests. Instead, in these tests oxides formed on the outer specimen surfaces and along the main transgranular cracks that caused fatigue failure. These observations indicate that the formation of oxide along the grain boundaries is prevalent in the presence of tensile creep which is common for both the TCIP and TMIP tests.

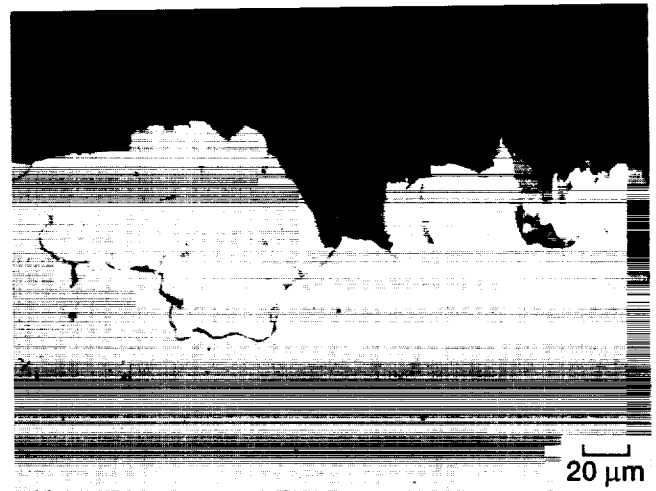
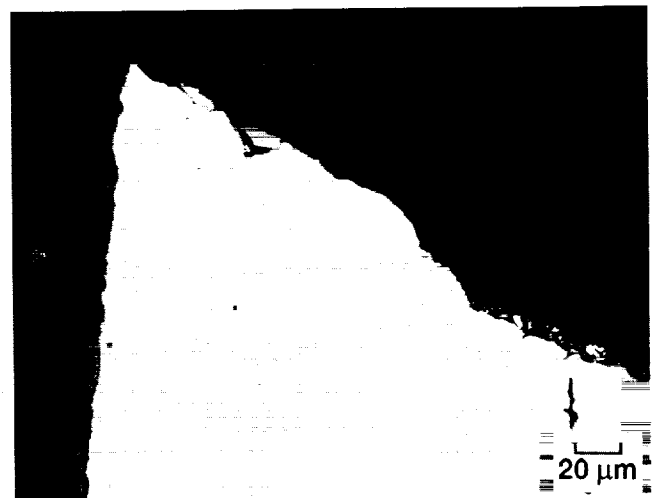
(a) TMIP test.

(b) TMOP test.

Figure 9.—Oxide formation in thermomechanical tests.

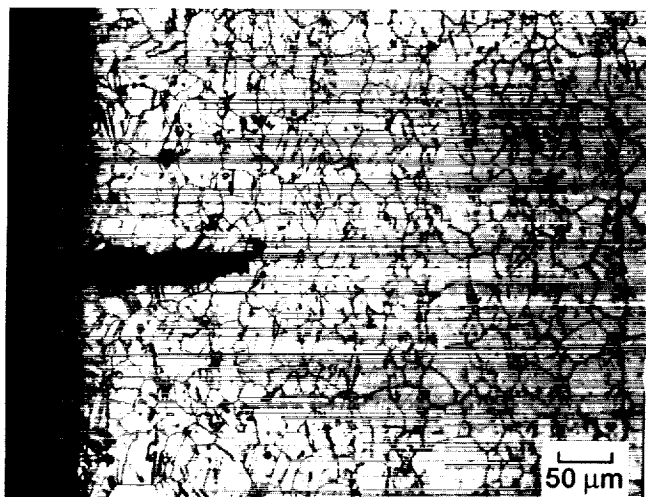
Figure 10.—Secondary crack in the bithermal HRIP test.

A secondary crack that was close to the fracture surface in the bithermal HRIP test is shown in figure 10. Evidence of grain boundary carbide precipitation is also seen in the HRIP test. In the bithermal HROP test (fig. 11), the following were observed: Small amounts of  $M_{23}C_6$  carbides within the grains (in addition to the precipitation along the grain and twin boundaries) and crystallographic slip that produced distortion of the twin boundaries. The microstructures of bithermal HRIP and HROP tests, while exhibiting subtle differences, were basically similar. In the TCIP test, precipitation and accumulation of  $M_{23}C_6$  carbides along the grain boundaries and cracking of transversely oriented grain boundaries were noticed (fig. 12). In the CCOP test, transgranular fracture, distortion of grains and twins due to plastic deformation (probably due to tensile overload at the end of the test), occurred in addition to the intergranular precipitation of carbides (fig. 13).

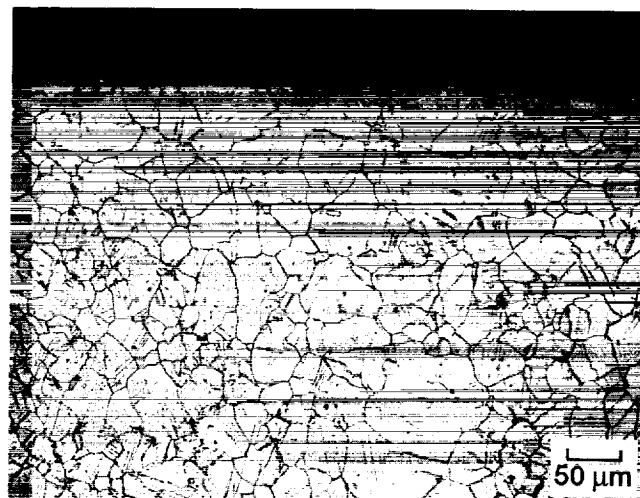
Figure 11.—Intragranular precipitation of carbides, distortion of twins, and slip plane activity in the bithermal HROP test.

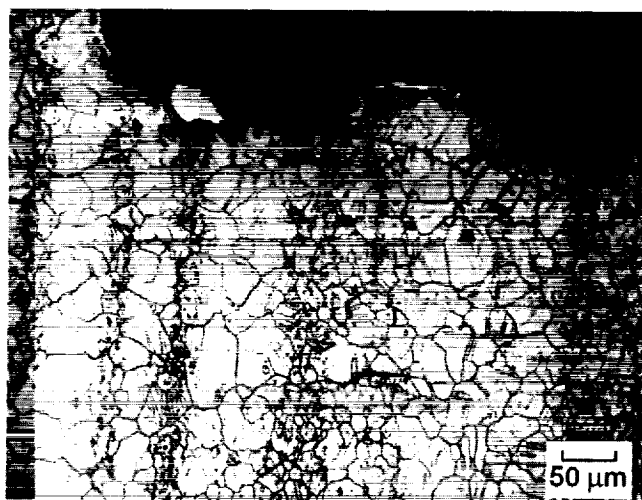
Figure 12.—Grain boundary carbide precipitation and cracking of transverse grain boundaries in the bithermal TCIP test.

In the BF as well as TMF tests, the microstructure of the failed samples revealed precipitation of  $M_{23}C_6$  carbides mainly along the grain boundaries. Precipitation and accumulation of carbides along the grain boundaries and cracking of the transversely oriented grain boundaries were noticed in the TCIP and TMIP tests (figs. 12 and 14). Grain boundary carbide precipitation and accumulation were also observed in both CCOP and TMOP tests. However, cracking within the longitudinally oriented grain boundaries was observed in some areas only in the TMOP test (figs. 15). The significance of this observation is unknown. It is believed that the accumulation of carbide precipitates in the grain boundaries caused embrittlement and made them susceptible to fracture at prolonged exposure times. Thus, several similarities exist in the modes of cracking, formation of oxide layers, and metallurgical microstructures among the in-phase and out-of-phase BF and TMF fatigue tests of Haynes 188. These similarities provide phenomenological bases for the utilization of bithermal fatigue data in thermomechanical fatigue life prediction. Indeed, Halford et al. (ref. 15) successfully predicted the in-phase and out-of-phase TMF fatigue lives of Haynes 188 to within a factor 2 by using the BF data reported in reference 5. However, it must be pointed out that the similarities between the damage mechanisms of BF and TMF tests may not exist for other materials and temperature regimes. Thus, it is the responsibility of fatigue life estimator to ascertain that there are indeed similar damage mechanisms occurring in BF and TMF tests before attempting to use the BF data as the basis for TMF life prediction.

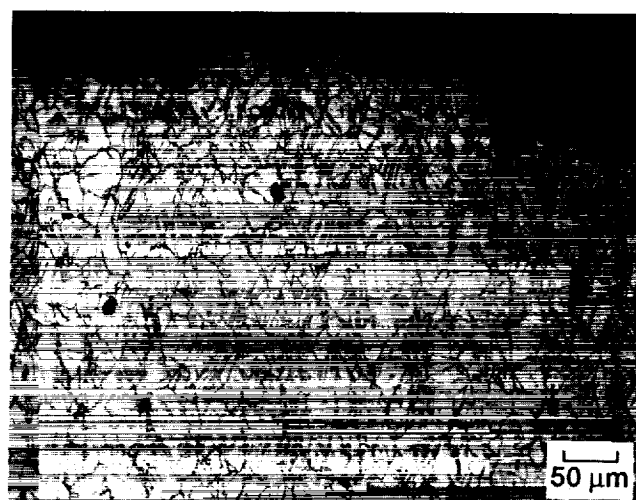
Figure 13.—Transgranular cracking, distortion of twins, and precipitation of carbides in the bithermal CCOP test.

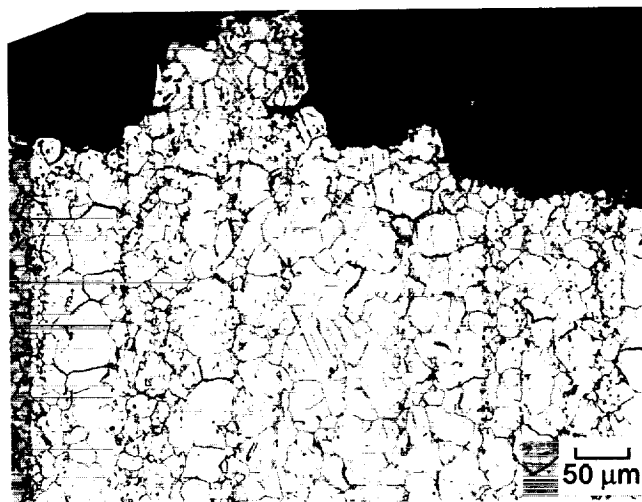
Figure 14.—Intergranular carbide precipitation and fracture in TMIP test.

Microstructure of the in-phase TMF test (fig. 14) indicated small amounts of intergranular  $M_{23}C_6$  carbide precipitation and an accumulation of these carbides in some locations. Intergranular fracture along the main crack that caused failure and at other locations is distinctly visible in figure 14. Intergranular carbide precipitation and cracking within the longitudinal grain boundaries near the fracture surface were observed in a TMOP test (fig. 15). However, the main crack that caused failure in the TMOP test was transgranular. Table II summarizes the fractographic and metallographic observations.

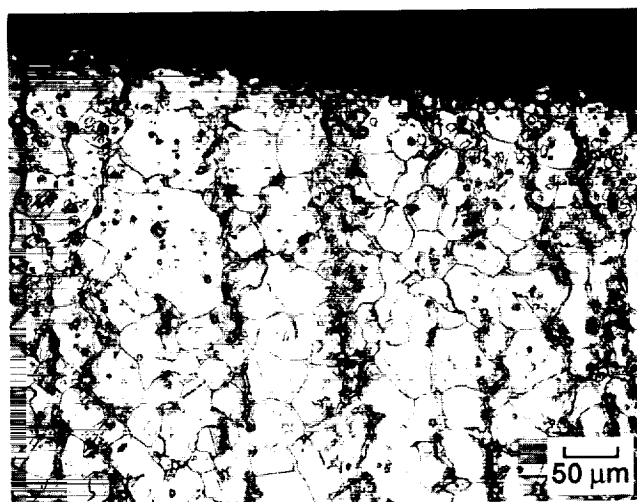
Figure 15.—Intergranular carbide precipitation and transgranular fracture in TMOP test.
